# Manhole Inspection Summary

Manhole # S31I\_\_003MH

Insp Date: **11/12/08 1:08 PM**

**Location** Address: **s paca st**

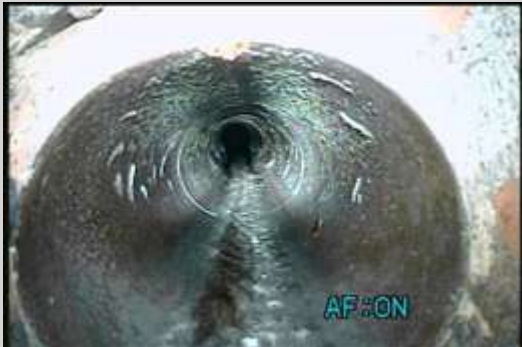
12 O'Clock Outflow

10 in. Circular Gravity Sewer  
Pipe Out @ 12 O'Clock

Pipe Material: **Clay** ☐ Pipe Lined

Invert Depth: **12.92** (ft.) Flow Characteristics: **Slow**

Deposits: ☒ None ☐ Mud ☐ Sludge ☐ **Debris** ☐ Grease

Infiltration: **None** Pipe Seal Cond: **Unknown**

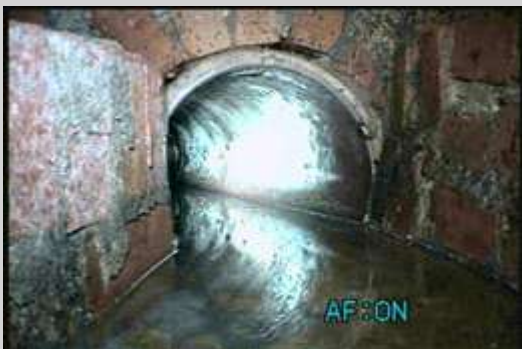
3 O'Clock Inflow

10 in. Circular Gravity Sewer  
Pipe In @ 3 O'Clock

Pipe Material: **Clay** ☐ Pipe Lined

Invert Depth: **12.58** (ft.) Flow Characteristics: **Slow**

Deposits: ☒ None ☐ Mud ☐ Sludge ☐ **Debris** ☐ Grease

Infiltration: **None** Pipe Seal Cond: **Unknown**

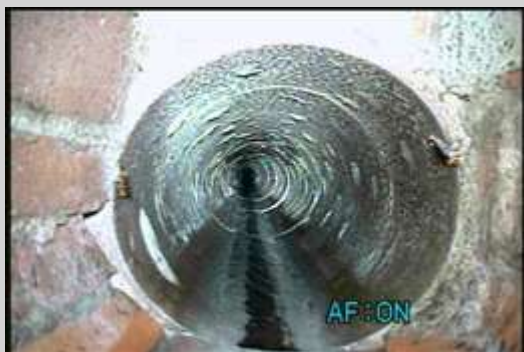
7 O'Clock Inflow

10 in. Circular Gravity Sewer

Pipe In @ 7 O'Clock

Pipe Material: Clay ☐ Pipe Lined

Infiltration: None Pipe Seal Cond: Unknown
